Spontaneous bilateral rod fracture of malleable penile prosthesis

Izmir Bozkyaka Training and Research Hospital, Izmir, Turkey

Cite as: *Can Urol Assoc J* 2014;8(9-10):e739-40. <http://dx.doi.org/10.5489/cuaj.2005>
Published online October 22, 2014.

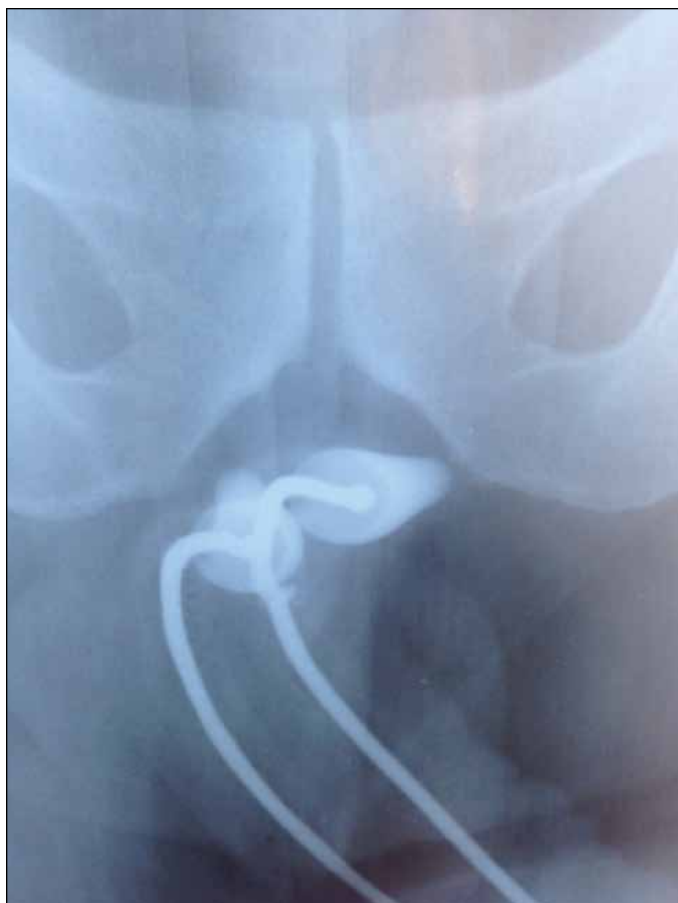
had been satisfied with the device for 14 years. In 2014, he complained of a decrease in penile rigidity, bending of the penis to the left side and a crackling sound during sexual intercourse lasting for the preceding 6 weeks. On physical examination, the left and right rods were instable at 1/3 proximal and 1/3 distal parts, respectively. There was no edema, local tenderness or erythema on the sites of instability. The broken part of the left rod was confirmed by plain X-ray film (Fig. 1).

Fig. 1. X-ray film showing the left rod fracture.

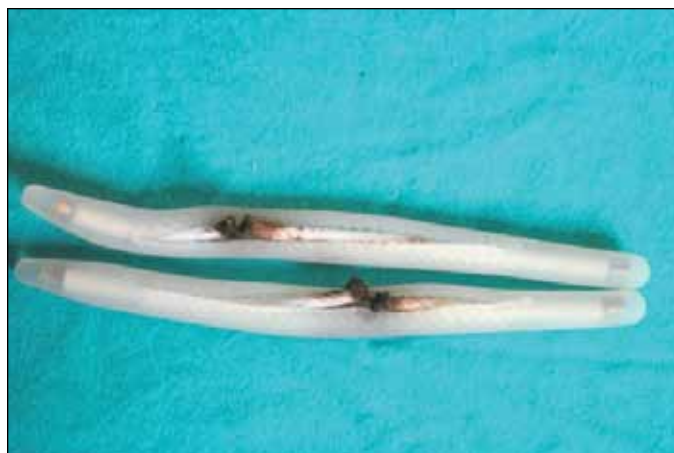
On further questioning, the patient stated that he did not have any vigorous intercourse or any trauma that may have caused the breakage. Surgical exploration was performed through a midline penoscrotal incision. The corporal bodies were intact. After the removal of both rods, we implanted a new malleable device during the same session (Fig. 2, Fig. 3).

Fig. 2. Bilateral AMS 650 rod fracture.

The AMS 650 malleable penile prosthesis has a fabric-wrapped stainless steel core covered with a synthetic braid. The outer layer consists of a silicone elastomer body that provides considerable girth. The first case of mechanical failure with AMS 650 malleable penile prosthesis was reported in 2007.³ In this case, the fracture was unilateral and determined after 6 years. Interestingly, this prosthesis and the prosthesis in our report were implanted in the same year in the same country, but at different institutions.

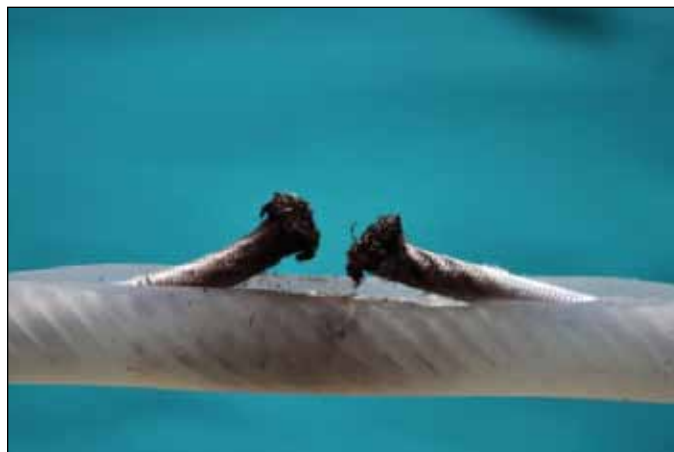
Fig. 3. Broken rod, closer view.
