Spontaneous fracture of indwelling polyurethane ureteral stents: A case series and review of literature

Cite as: *Can Urol Assoc J* 2012;6(5):386-92. <http://dx.doi.org/10.5489/cuaj.12013>

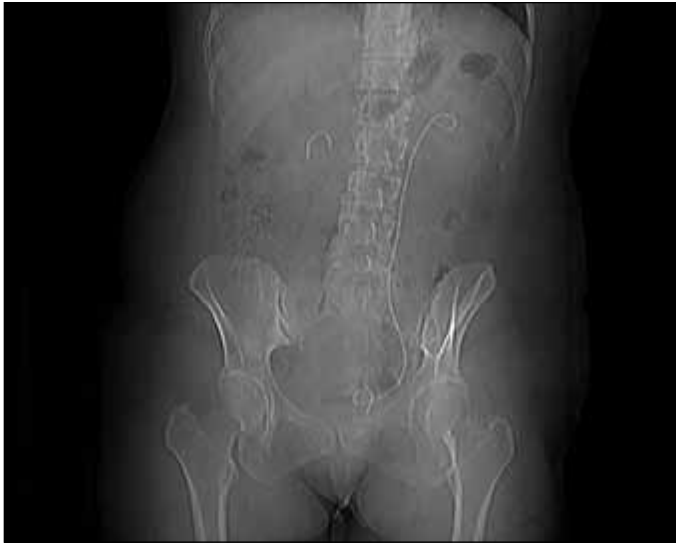
Fig. 1. Computed tomography scout film showing a fragment of stent left at the right renal pelvis and an indwelling left ureteral stent.

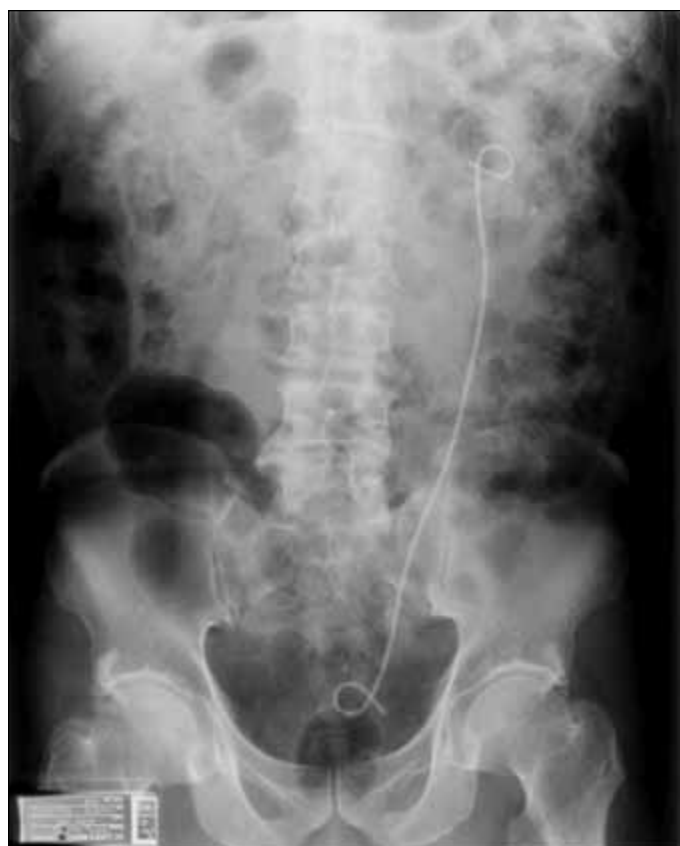
Fig. 2. Kidney, ureter, bladder x-ray showing an indwelling left ureteral stent in place.

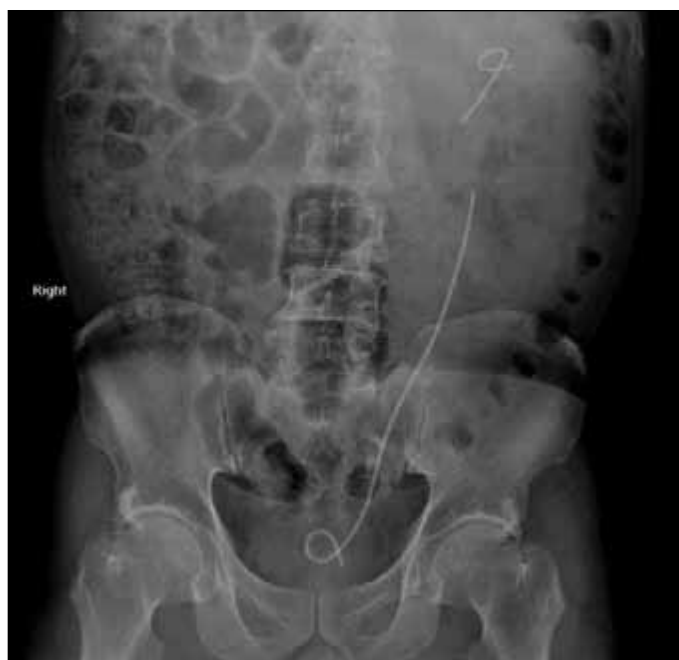
Fig. 3. Kidney, ureter, bladder x-ray showed a fragmented left ureteral stent, with the point of fracture at the proximal renal end.

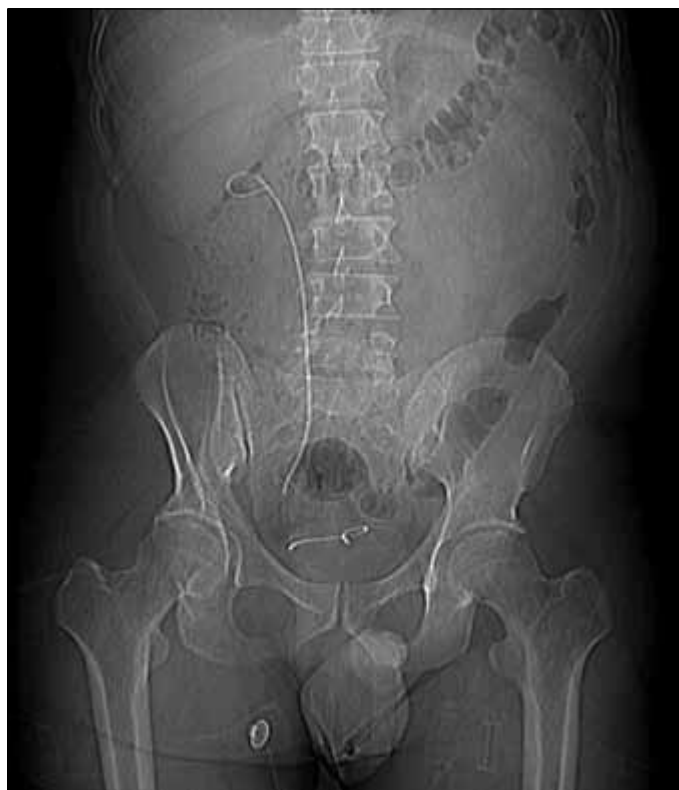
Fig. 4. Computed tomography scout film showing a fragmented ureteral stent point of fracture at the distal bladder end.

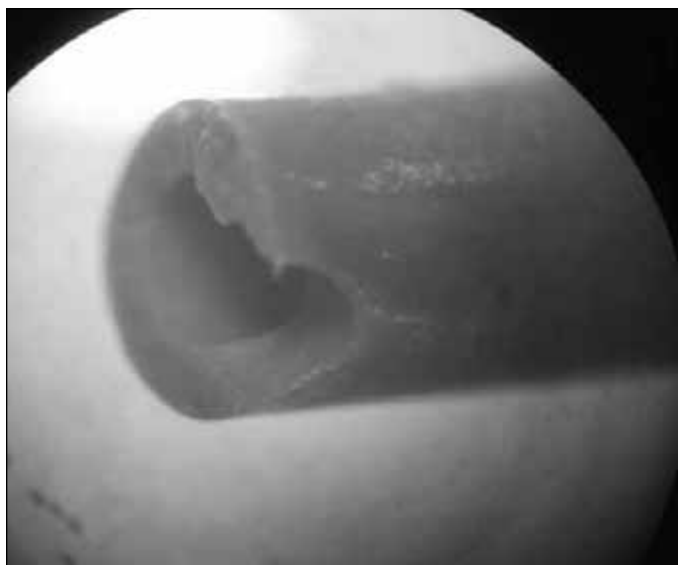
Fig. 7. Second image: microscopic imaging of the stent fragment (magnification $\times 500$) showing line of breakage traversing the polyurethane ureteral stent side hole near the distal bladder end.

frequent as silicone and other biomaterial stents. Fracture of the polyurethane stents may also be caused by repeated mechanical stress, especially along the side holes.²⁴ It has been reported that most fracture points were also along the drainage holes; therefore, the incidence of ureteral stent fracture can be decreased by eliminating these holes.²⁰ In our cases, most fractures were at the proximal renal end and, on the microscopic finding of the retrieved stents, the breakage line traverses the ureteral stent side holes. Upon preoperative radiological workup of our patients, we found that most of the inserted polyurethane ureteral stents lengths were longer than appropriate; this may have led to an increase in mechanical stress to the stent.

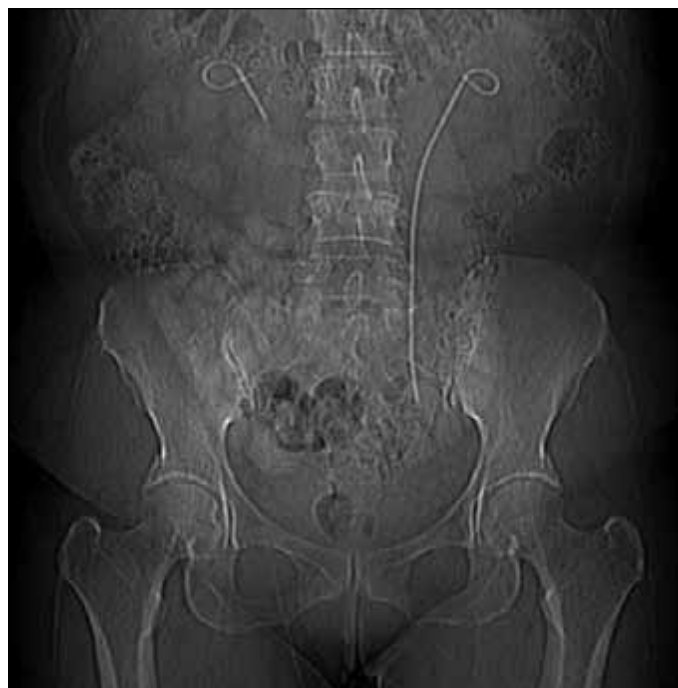
Fig. 8. Computed tomography scout film showing bilateral fractured stent; a piece of retained right ureteral stent on the right pelvis and a retained segment of left ureteral stent with a missing bladder end.

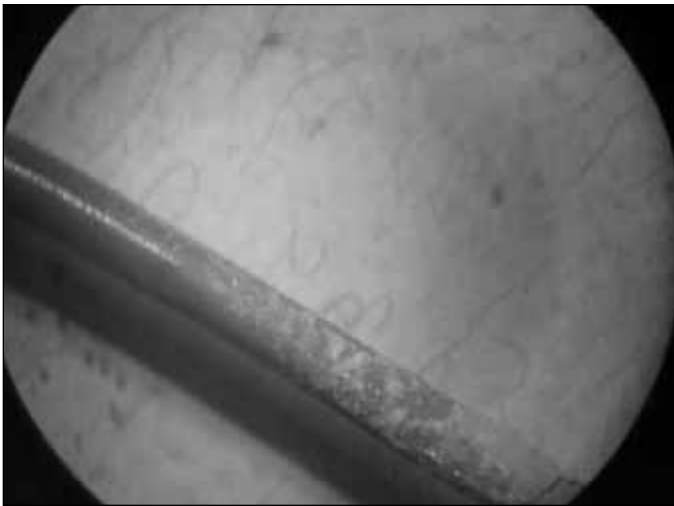
Fig. 9. Removed polyurethane ureteral stent fragments were noted moderately encrusted and breakage lines are noted along the stent side hole.
