Management of pyelovesical bypass device stones

Ahmad Almarzouq, MD, MSc; Sero Andonian, MD, MSc, FRCSC, FACS
Department of Urology, McGill University Health Centre, Montreal, QC, Canada

Cite as: *Can Urol Assoc J* 2018 Feb. 6; Epub ahead of print. <http://dx.doi.org/10.5489/cuaj.4857>

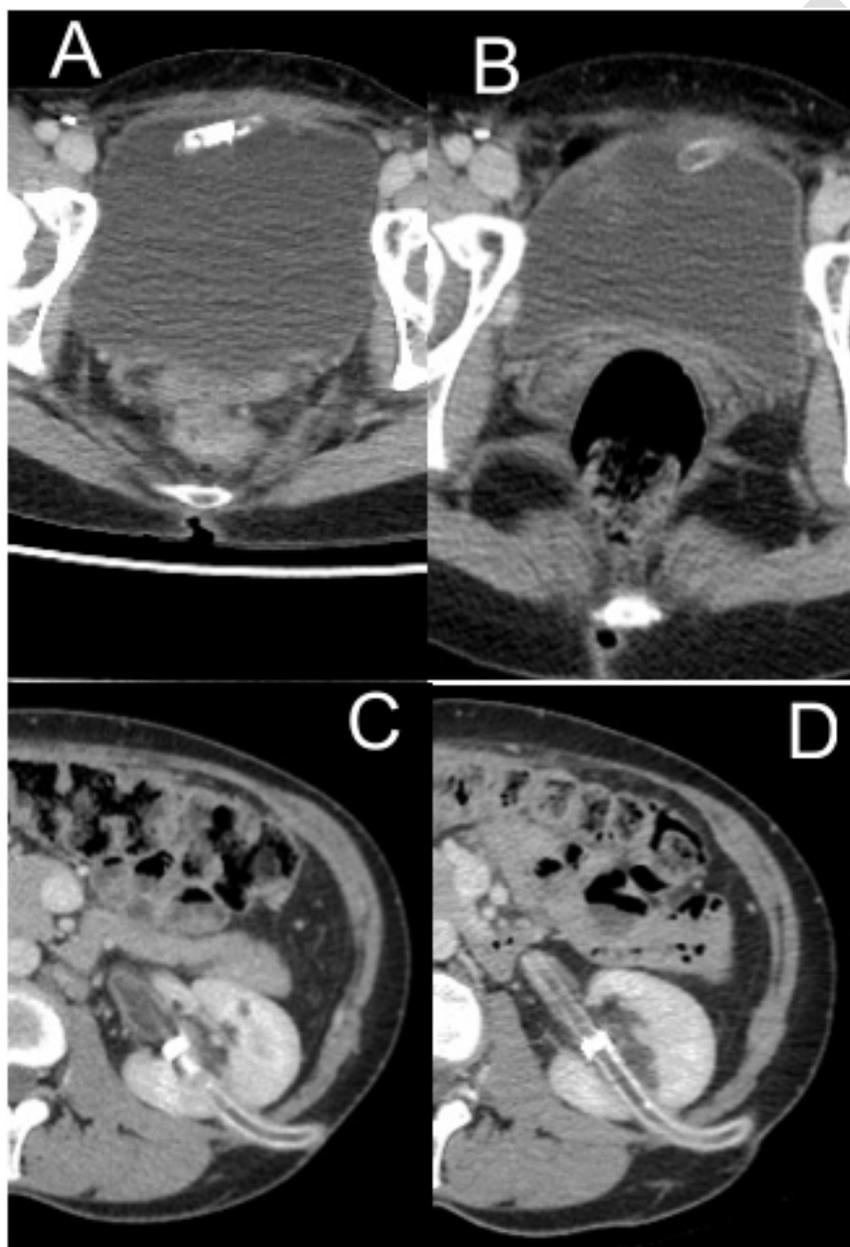
Fig. 1. (A) Axial images of the distal tip of the device with encrustations. (B) Axial images of the distal tip of the device post resection and Holmium laser fragmentation. (C) Axial images of the left Renal pelvis illustrating encrustations at the proximal tip of the device causing obstruction. (D) Axial images of the left renal pelvis illustrating clearance of the intra-luminal encrustations and resolution of the hydronephrosis post ureteroscopy and Holmium laser fragmentation.

Six months following the insertion of the Detour™ device, the patient presented with gross hematuria and recurrent urinary tract infections (UTIs). CT scan showed calcifications on the distal silicone tip of the Detour device which was later confirmed with cystoscopy (Figure 1A). There were no other calcifications. The encrusted Detour™ was managed cystoscopically by cutting the 2 cm intra-vesical silicone portion of the device in addition to Holmium laser lithotripsy of the intraluminal calcifications with a flexible ureteroscope (Figure 1B). Stone analysis revealed calcium phosphate and metabolic stone work-up showed hypercalciuria which was treated with hydrochlorothiazide-amiloride. The recurrent UTIs were treated with prophylactic nitrofurantoin and mandelamine. She had closure of her colostomy and repair of her ventral hernia. Four years after resection of the distal tip of the Detour™ device, she presented with encrustations in the proximal tip of the Detour™ device causing hydronephrosis (Figure 1C). A second flexible ureteroscopy was performed and intraluminal calcifications were pulverized using Holmium laser leading to successful clearance of the stone burden and reversal of the hydronephrosis (Figure 1D).
