**Case – Endoscopic and endovascular management of inferior vena cava filter erosion into the right proximal ureter**

**Cite as:** Jacox N, Yao HH-I, Mirakhur A, et al. Case – Endoscopic and endovascular management of inferior vena cava filter erosion into the right proximal ureter  
*Can Urol Assoc J* 2021 August 26; Epub ahead of print. <http://dx.doi.org/10.5489/cuaj.7295>

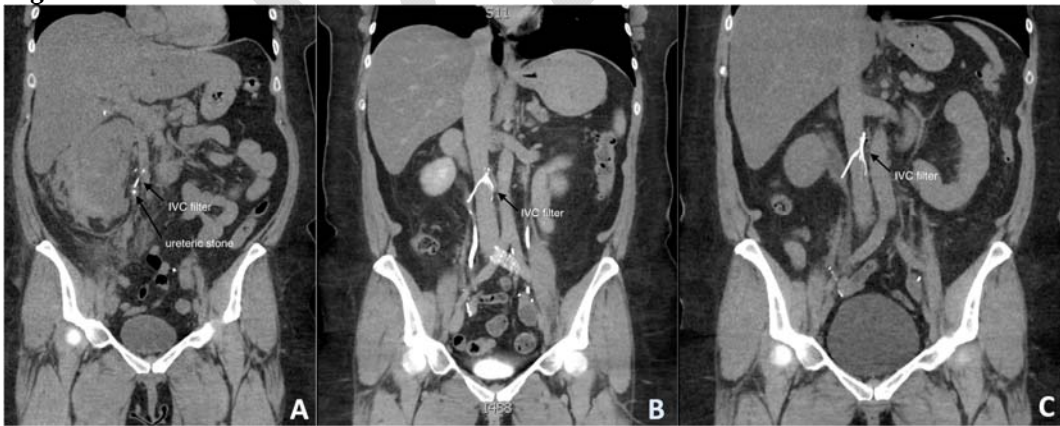
*Fig. 2.*

A 47-year-old woman presented with right flank pain. She had a retrievable IVC filter (Celect™, Cook Medical) placed eight years ago, prior to an elective gynecologic surgery due to her increased risk of thrombosis secondary to May-Thurner syndrome. Sixteen months after IVC filter insertion she presented with right flank pain; CT scan did not reveal hydronephrosis nor any cause for her pain. One month later she underwent an attempted filter removal, which failed due to significant filter tilting and leg penetration beyond the IVC wall (Figure 1A). Six years later she underwent percutaneous nephrolithotomy to remove a 1.4cm right lower pole stone. Post-operatively, one stone fragment fell into the ureter and she presented with renal colic after 11 days (Figure 2A) CT scan revealed the stone was lodged at

the location of IVC filter leg protrusion into the right proximal ureter, associated with proximal hydroureteronephrosis.

Right ureteroscopic laser stone extraction was performed and follow-up imaging confirmed resolution of the hydronephrosis. At the time of PCNL and ureteroscopy, there was no foreign body visualized in the ureteric lumen. Despite resolution of hydronephrosis, her right sided flank pain continued to worsen. Two years later CT scan revealed new hydroureteronephrosis above the level of IVC filter leg protrusion into the proximal ureter (Figure 2C).

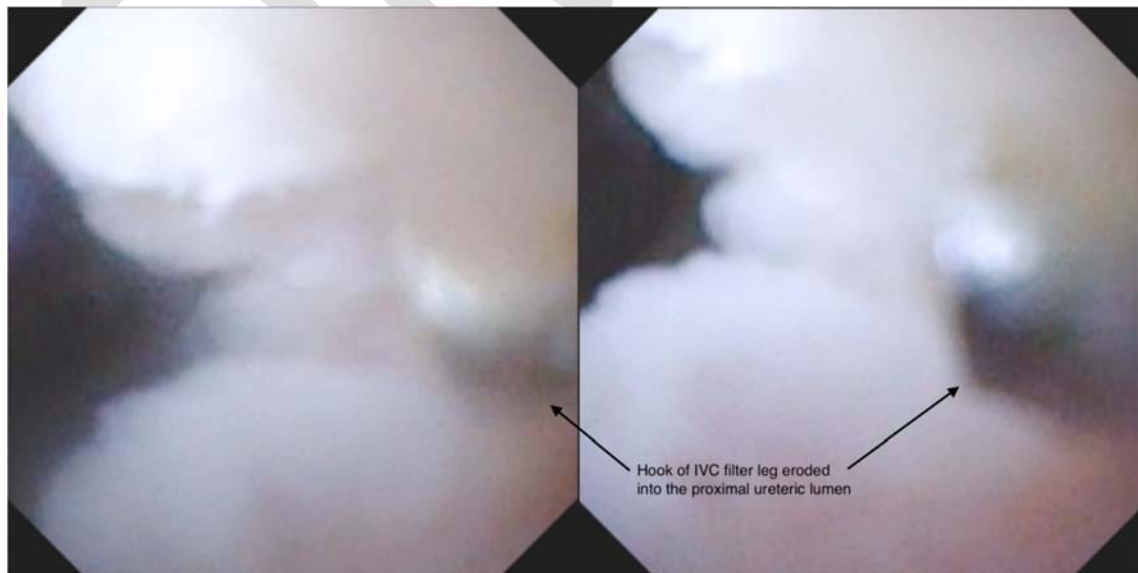
**Fig. 4.**

Hoping to resolve her symptoms, she consented to re-attempt filter removal. A multidisciplinary discussion recommended deferring endovascular removal pending endoscopic removal of the ureteral component, given the protrusion of the IVC filter strut into the collecting system. She underwent a right ureteropyeloscopy to endoscopically treat the IVC filter leg that had eroded into the ureter. The IVC filter leg was visualized within the proximal ureter and noted to have a hook-like configuration protruding into the ureteric lumen (Figure 4).
