**Case series – Small bowel obstruction secondary to retained male urinary and sexual prostheses reservoirs**

**Cite as:** Loloi J, Davila J, Babar M, et al. Case series – Small bowel obstruction secondary to retained male urinary and sexual prostheses reservoirs. *Can Urol Assoc J* 2022 February 28; Epub ahead of print. <http://dx.doi.org/10.5489/cuaj.7773>

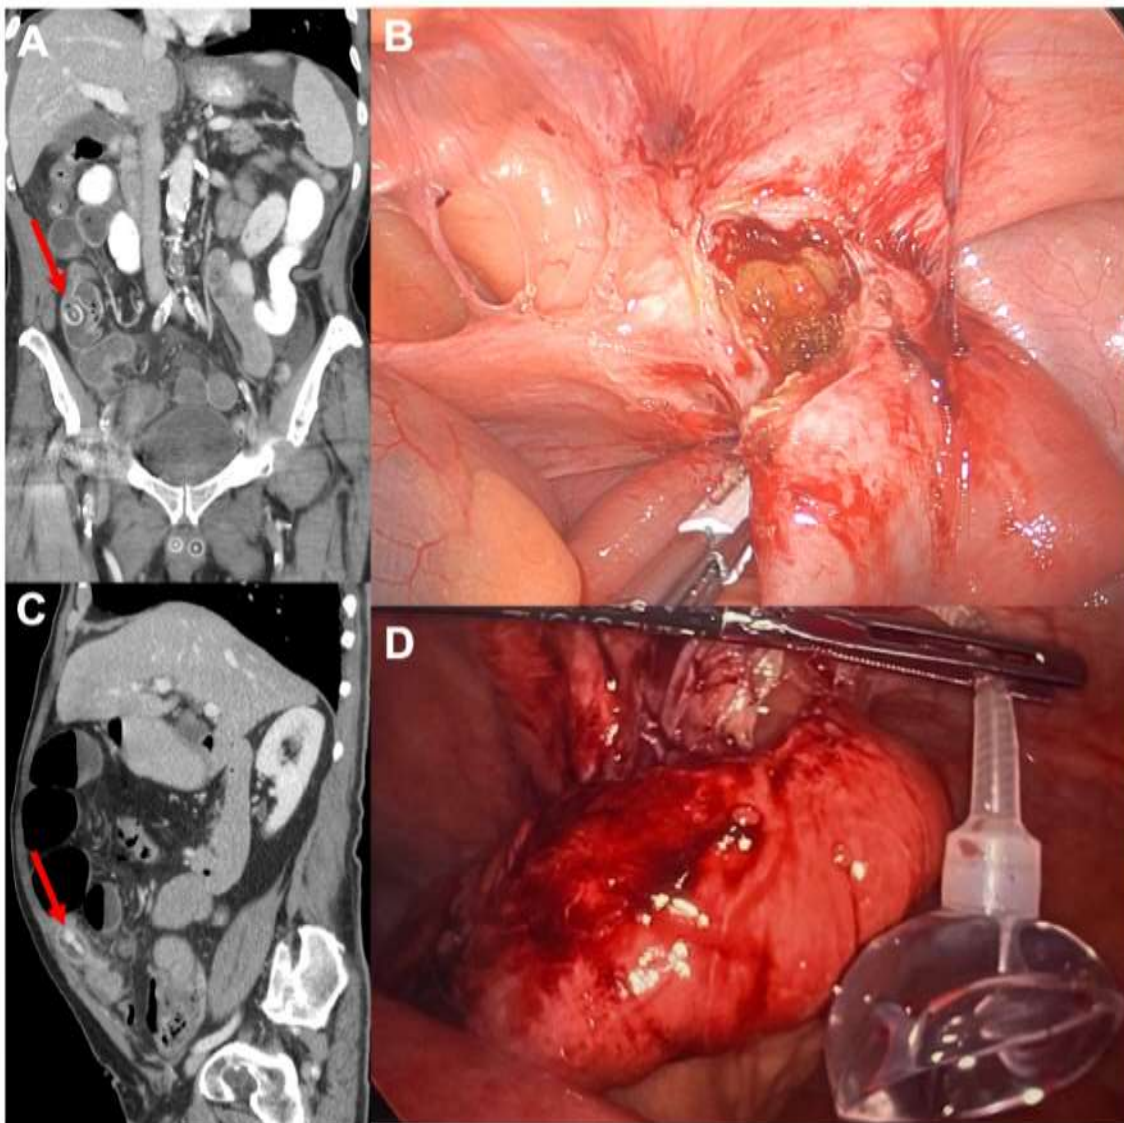
## Figures and Tables

**Figure 1.** (A) *Case 1:* SBO with a transition within the terminal ileum due and an endoluminal foreign body in the cecum (consistent with a retained reservoir). (B) *Case 1:* Diagnostic laparoscopy revealing a thickened terminal ileum, walled-off perforation in the RLQ, thought to be due to reservoir entry into the small bowel. (C) *Case 2:* CT scan with dilated loops of small bowel with an abrupt transition point in the RLQ adjacent to the retained reservoir. (D) *Case 2:* Exploratory laparotomy revealing a SBO with the reservoir and tubing embedded into the small bowel wall.

abdomen/pelvis revealed a SBO with a transition within the terminal ileum from an endoluminal foreign body (Figure A). The foreign body was a lobulated radiodense structure measuring 5 x 3.5 cm with an anterior elongated radiodense component. Additionally, imaging showed a surrounding 5.5 x 2 cm rim-enhancing collection containing fluid and gas extending from the pelvic ileum into the right groin at the site of fistulous communication of the foreign body, bowel, and skin. This was consistent with a SBO with enterocutaneous (EC) fistula secondary to migration of a IPP reservoir into the small bowel.

The patient was started on antibiotics and a nasogastric tube (NGT). Two days later, diagnostic laparoscopy revealed a thickened terminal ileum and a right pelvic wall fistula with an additional loop of small bowel closely associated (Figure B). The small bowel was assessed and no intraluminal foreign body was identified. A colonoscope was then passed through the small bowel defect into the cecum, ascending colon, and retrograde into the terminal ileum. No foreign body was visualized. The small bowel fistula was resected and the small bowel was primarily anastomosed. A penrose drain was passed through the area of the fistula and skin to ensure ongoing drainage. Given the obstruction was relieved, it was believed the reservoir had migrated into the colon.

CT scan of the abdomen/pelvis revealed dilated loops of small bowel with an abrupt transition point in the right lower abdomen (Figure C). The reservoir was seen with a small residual portion of tubing extending to the transition point.

An NGT was placed and drained copious biliary fluid. Subsequent diagnostic laparoscopy revealed a bowel obstruction at the site of the AUS reservoir and tube, which appeared embedded into the small bowel wall (Figure D). The foreign bodies were retrieved and the affected bowel was resected and primarily anastomosed.
