Case – An invisible stent

Can Urol Assoc J 2022 October 25; Epub ahead of print. <http://dx.doi.org/10.5489/cuaj.8024>

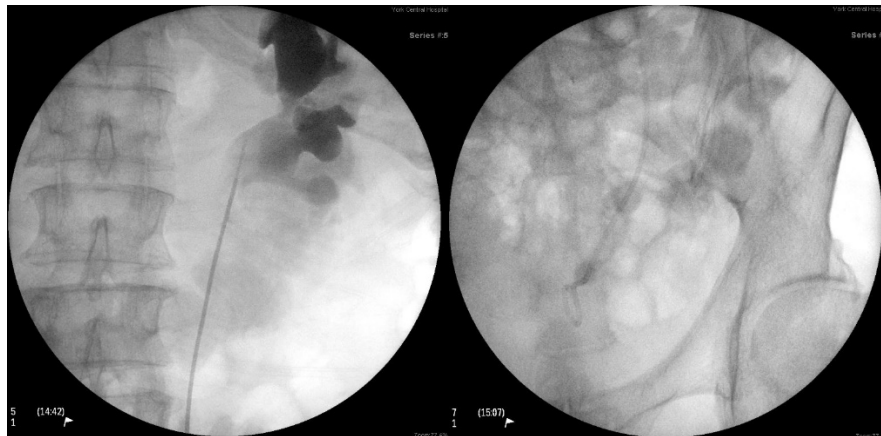
Figure 1. Proximal (left) and distal (right) curls of the original double-J ureteric stent, at the time of placement.

The patient underwent successful Greenlight TURP with left sided ureteral stent insertion (Cook Black Silicone Filiform Double Pigtail Stent – 6 French). Stent insertion was challenging due to severe tortuosity of the distal ureter, presumably related to the proximity of the ureter to the diverticulum. Stent insertion was ultimately achieved and retrograde pyelography demonstrated the radiopaque, intact ureteric stent with the proximal and distal curls in their appropriate locations (Figure 1). A year later, at the time of the planned stent exchange, the stent was entirely invisible on fluoroscopy as evident in (Figure 2). Interestingly, the stent was easily found on cystoscopy and was successfully retrieved intact with minimal encrustation or visible degradation. Ex-vivo fluoroscopy demonstrated that this stent was significantly more radiolucent compared to a new, out-of-the-box stent (Figure 3). Finally, a new left sided stent was inserted over a wire. Fluoroscopic images confirmed that this new stent was radiopaque, with its proximal and distal curls in appropriate positioning (Figure 4).

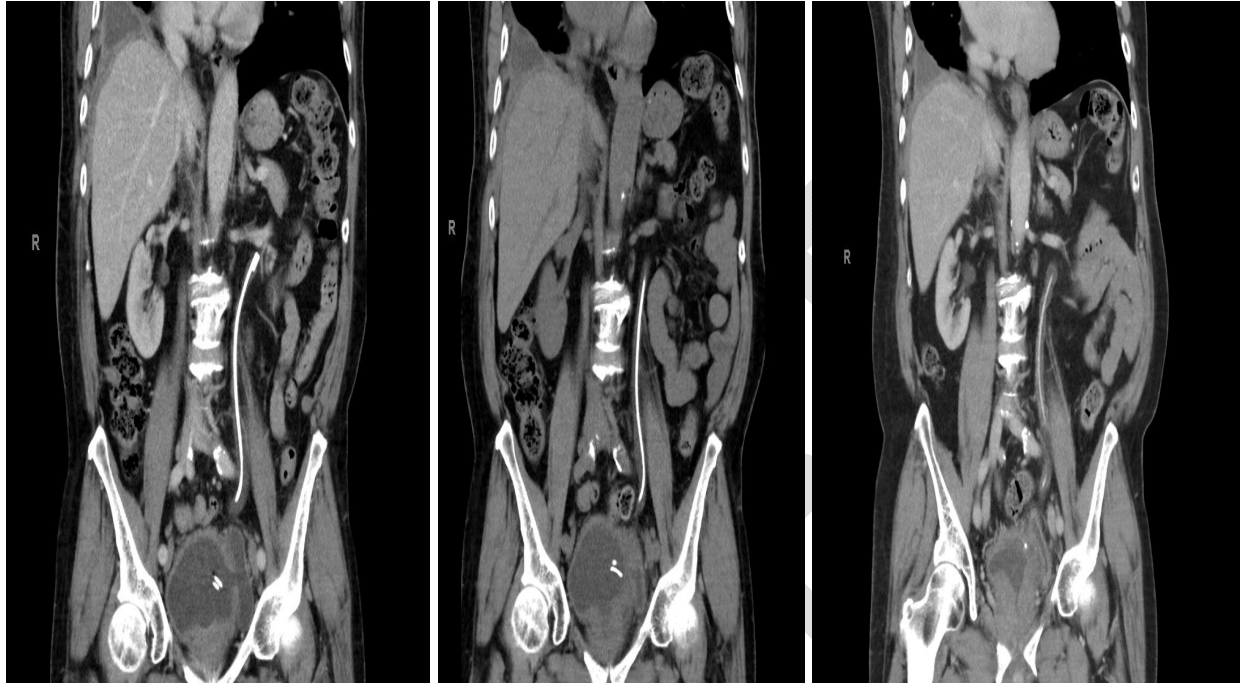
Figure 5. Staging computed tomography scans performed by medical oncology on August 25, 2021; November 27, 2020; and March 4, 2021 (from left to right).

We reviewed the staging CT scans performed by our colleagues in medical oncology in the interim between the insertion of the stent and stent change. Interestingly, the stent was seen to be gradually losing its radio-opacity on CT imaging as shown on the CT scans from different dates in (Figure 5).
